This is a summary of activities carried out by KLTC Technical Team during JAN/FEB 2024 in an effort to re-open The Brow footpath using a cost-effective approach that is low risk and safe for Public access.

Monthly Report No.3 – 06FEB24 was presented to Kirkby Lonsdale Town Council at the monthly Council meeting on 14FEB24.

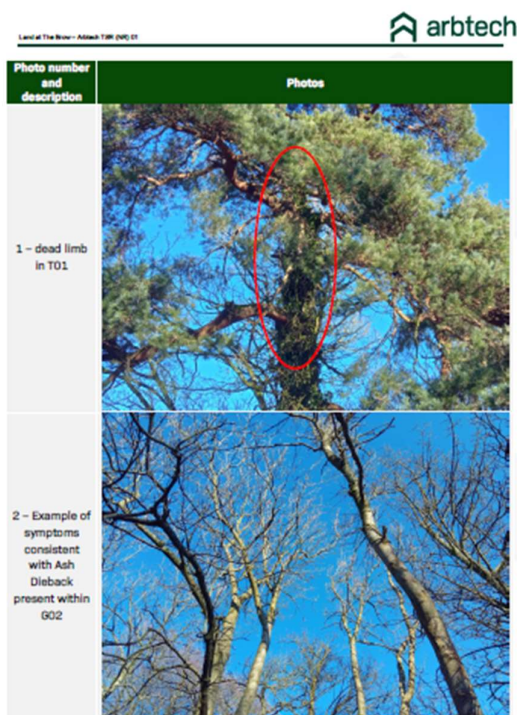
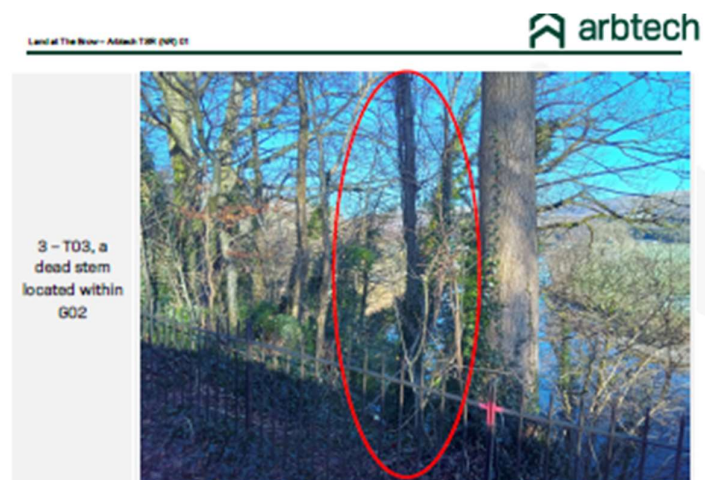
In summary, no major cropping or felling of trees is required, only general pruning of large branches overhanging the footpath and in danger of falling. Ivy has become very intrusive along the footpath and around trees, therefore it is recommended to sever ivy to aid future inspections and fell dead ash trees (victims of ash dieback) to a safe height adjacent to path.

Advise from Arbtech Ltd is not to cut back mature trees in an attempt to reduce wind loading on the Brow embankment. Trees establish a deep root system as large as the canopy spread itself. Trees move and deflect in strong winds and the roots adapt to stormy weather growing stronger in their ground conditions and surroundings.

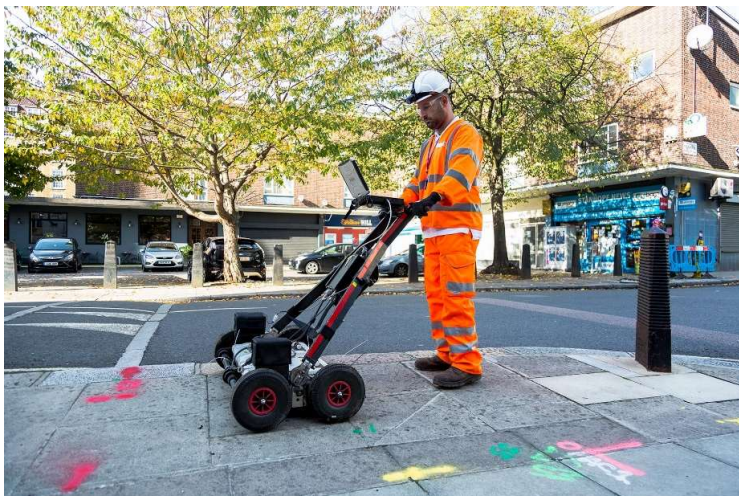
Planned work for the coming weeks includes a non-intrusive Drainage survey along the footpath and behind the stone retaining wall using Ground Penetration Radar (GPR shown) techniques shown below. This will prove the flow of rainwater over The Brow and into the River Lune. The concern is that surface water is percolating under the footpath and washing away fine soils supporting the edge of footpath.

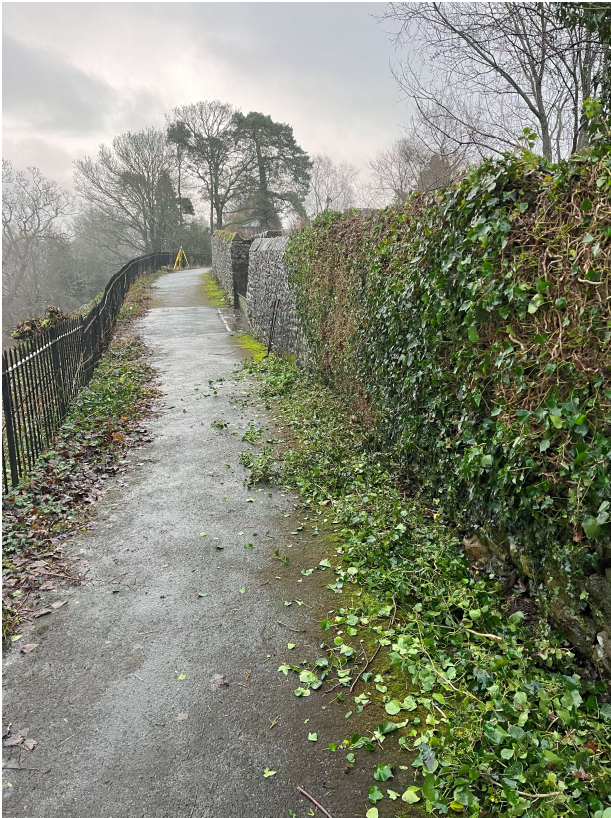
Before – intrusive ivy on the stone retaining wall

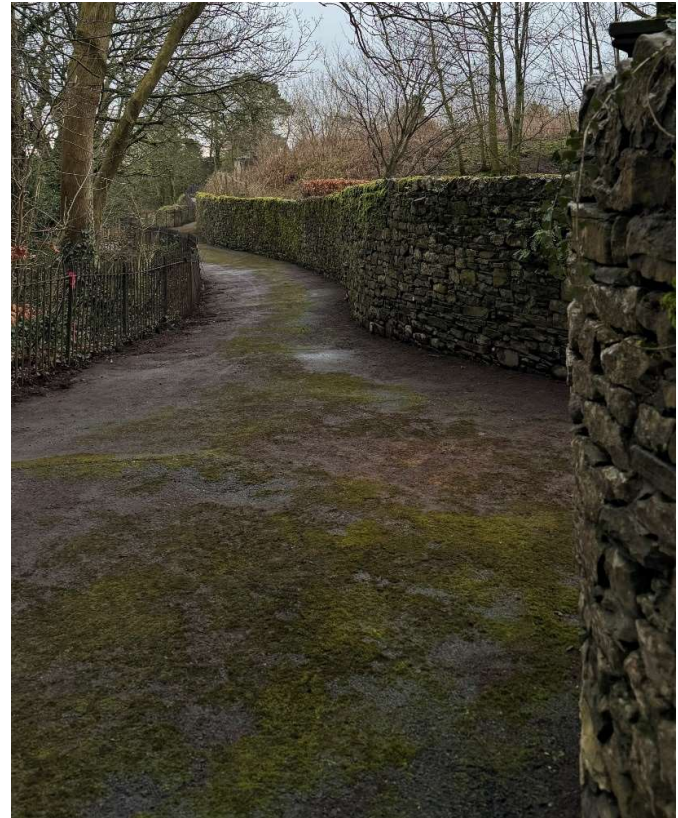
After – Ivy cleared for better 3D laser survey of stone wall
