The Brow - Technical Team  
 Monthly Report No.3 – FEB 2024

**Tree Safety Report (Negative/Hazardous reporting only)**

Land at The Brow,

30 January 2024

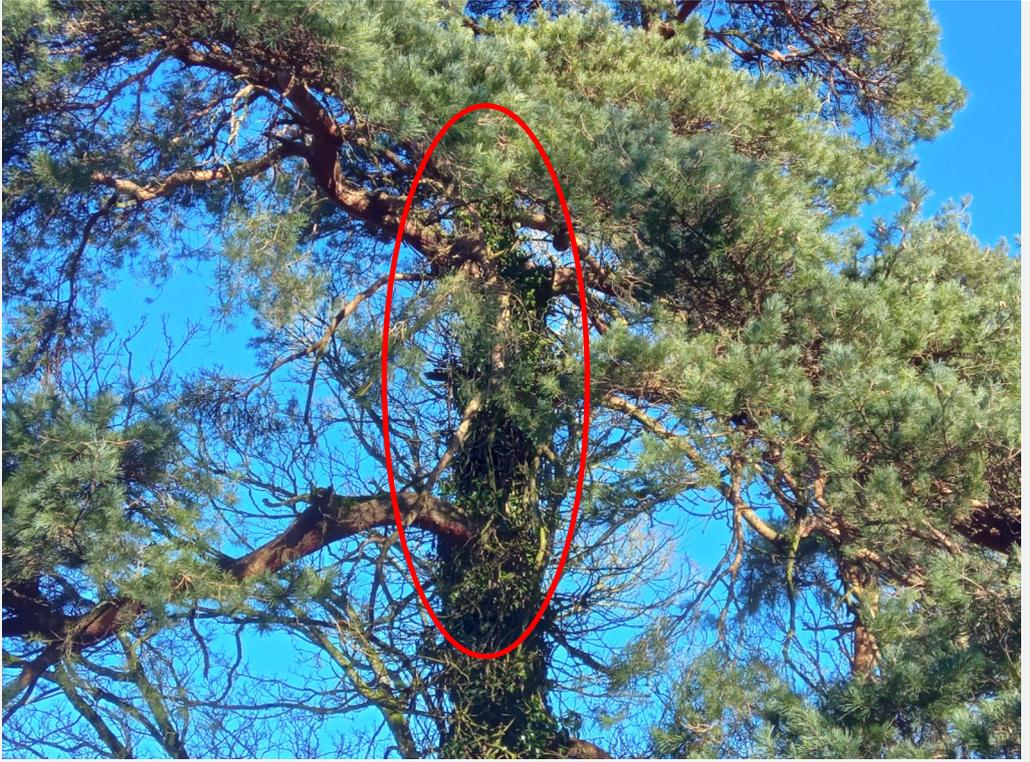
Photo number and description	Photos
1 – dead limb in T01

T01		Scots Pine (Pinus sylvestris)	Mature	21	7	1	1000	Prolific ivy; Other	Other	8	7	4	224	3	A	Localised pruning; Sever ivy (Remove failed limb at 12m on southern canopy - sever ivy to aid in future reinspection.)	Large tree located on a step back approximately 60 degrees from vertical; historically failed limb in the southern crown; ivy cladding from base to apex.
T02		Sycamore (Acer pseudoplatanus)	Mature	18	8	1	1200	Prolific ivy; Other	Prolific ivy	0.8	15	10	120	2	3Y	Localised pruning; Sever ivy (Sever ivy to aid in future reinspection - remove significant deadwood above 40mm diameter wherever present above path.)	Large tree located on a step back approximately 15 degrees from vertical - unable to thoroughly inspect the stem and base due to the slope; naturally occurring deadwood in the canopy; ivy cladding from base to apex.
T03		Common Ash (Fraxinus excelsior)	Early mature	10	1	1	120	Dead wood	Dead wood	2	15	4	120	2	3Y	Tree removal (Fell to safe height)	Standing deadwood

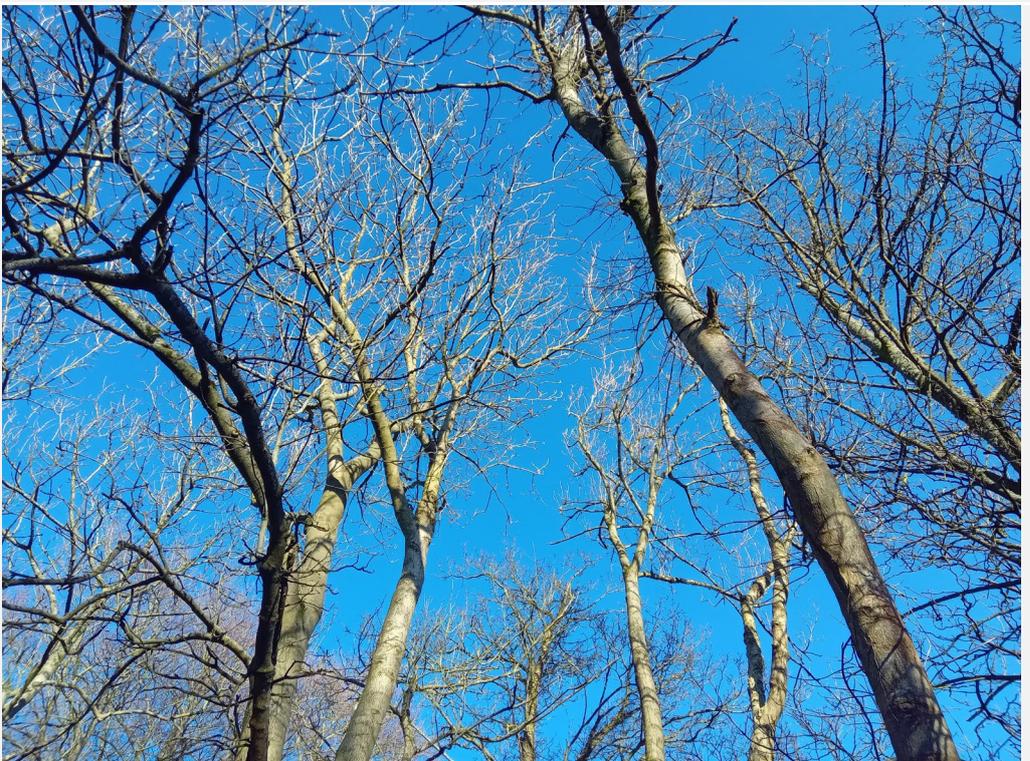
2 – Example of symptoms consistent with Ash Dieback present within G02

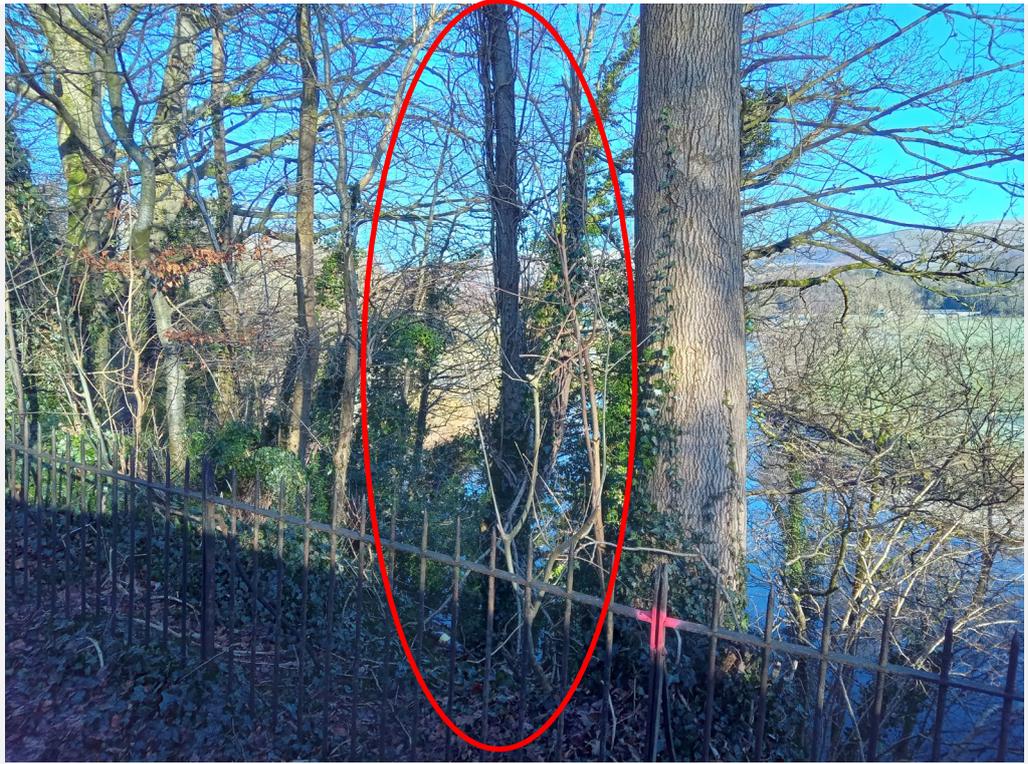
3 – T03, a  
dead stem  
located within  
G02

T03		Common Ash ( <i>Fraxinus excelsior</i> )	3Y	Tree removal (Fell to safe height)
