This is a summary of activities carried out by KLTC Technical Team during FEB/MAR 2024 in an effort to re-open The Brow footpath using a cost-effective approach that is low risk and safe for Public access.

Monthly Report No.4 – 12MAR24 was presented to Kirkby Lonsdale Town Council at the monthly Council meeting on 13MAR24.

Stage 1b – Survey Monitoring of The Brow:

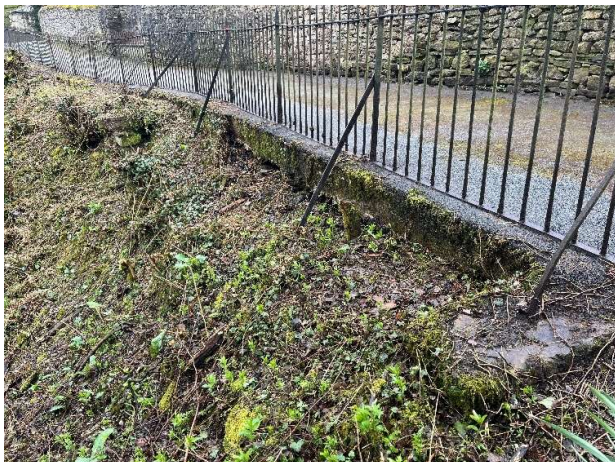
Further surveys will be required at the top of the embankment to check the condition of footpath support (existing gabions and concrete edge beams). It is likely that part of the footpath is 'undercut' because of drainage issues washing away 'fines' at the top of the embankment. See Photo 1.

Photo 1. – Undercutting of footpath.

Planned work for the coming weeks includes a non-intrusive Drainage survey along the footpath and behind the stone retaining wall using Ground Penetration Radar (GPR shown) techniques shown below. This will prove the flow of rainwater over The Brow and into the River Lune. The concern is that surface water is percolating under the footpath and washing away fine soils supporting the edge of footpath

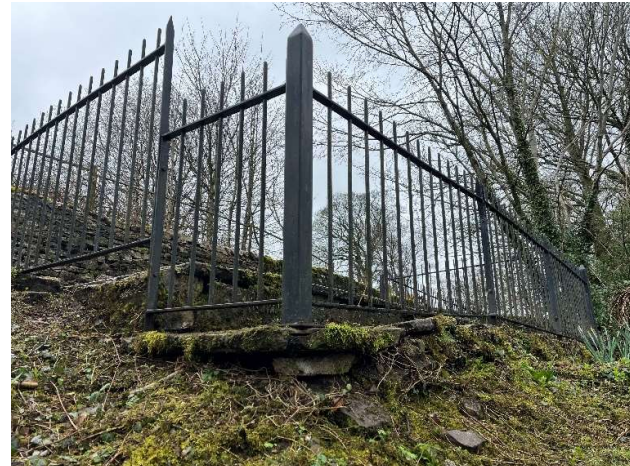
Photo 2. – No support under corner of North platform.

When The Brow was closed in SEPT 2021, there was concern that the North Viewing Platform was in a dangerous state – a corner showed signs of dropping. Our initial 'condition survey' shows why... there is no support or foundation under the slabs, only a simple rock. There is no land slide on the embankment, only poor foundation support, which can be easily rectified.

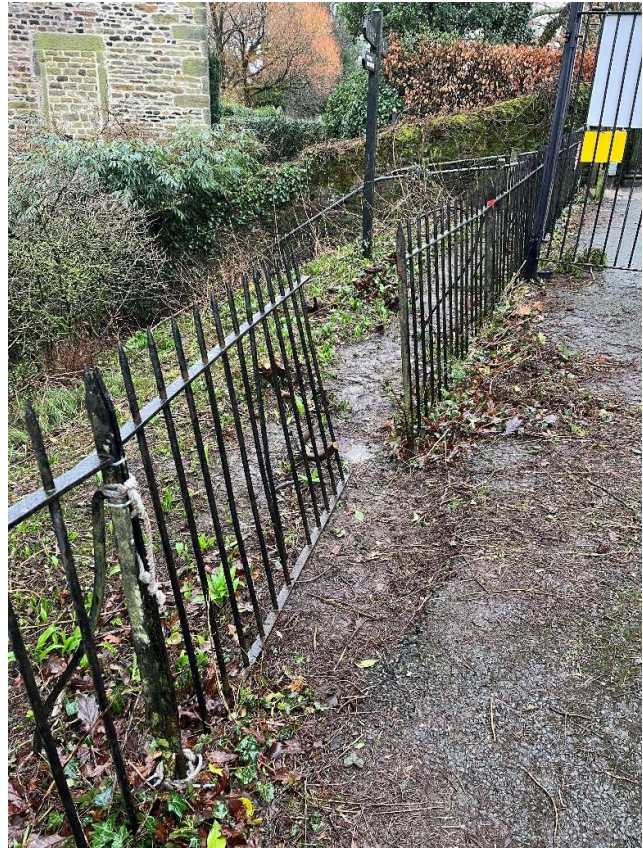
Despite locked gates preventing general access along The Brow, some pedestrians continue to climb over handrails at the top of Radical Steps and walk along a well-worn path next to the railings. One section of railings has now disappeared, being removed and taken by someone - lost forever through local vandalism.

Photo 4. – This section of railing is now missing...!

We will search the embankment for the lost section, but please get in touch if you know how or where we can recover the lost railing.
