This is a summary of activities carried out by KLTC Technical Team during JAN/FEB 2024 in an effort to re-open The Brow footpath using a cost-effective approach that is low risk and safe for Public access.

Monthly Report No.3 – 06FEB24 was presented to Kirkby Lonsdale Town Council at the monthly Council meeting on 14FEB24.

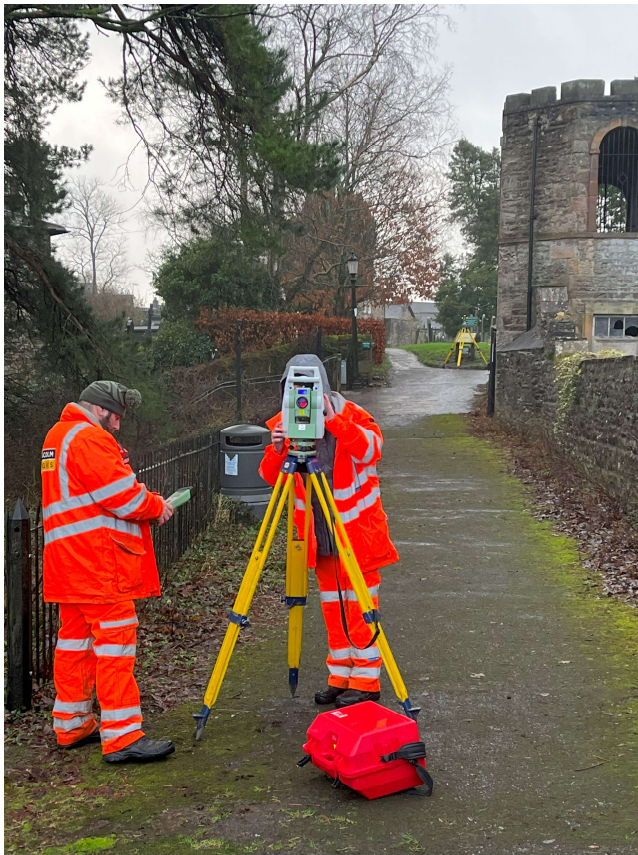
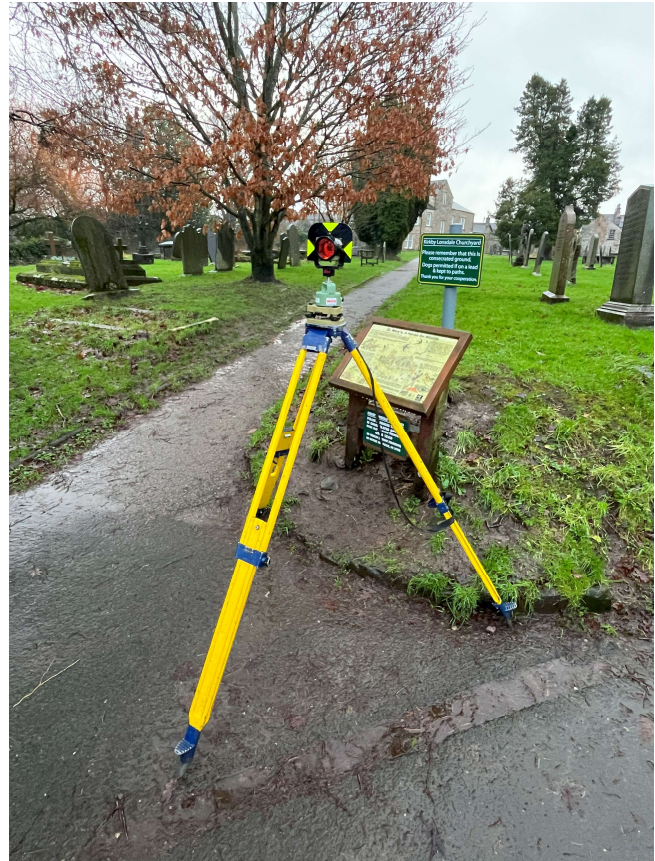
Further surveys will be required at the top of the embankment to check the condition of footpath support (existing gabions and concrete edge beams). It is likely that part of the footpath is ‘undercut’ because of drainage issues washing away ‘fines’ in the stone support.

Planned work for the coming weeks includes a non-intrusive Drainage survey along the footpath and behind the stone retaining wall using Ground Penetration Radar (GPR shown) techniques shown below. This will prove the flow of rainwater over The Brow and into the River Lune. The concern is that surface water is percolating under the footpath and washing away fine soils supporting the edge of footpath.
